The Labeller Speeds Up @ *Coopers*

Having regularly and effectively improved the main Labeller on Bottling Line 1 over the years, it was now time to look at the much older and slower Labeller machine to improve the Overall Equipment Effectiveness (OEE) of the Line.

The Topmatic Labeller on Bottling Line 1 at **Coopers Brewery, Regency Park SA** site had been identified as the bottleneck of the line when in use. Although not responsible for the majority of the products run on the Line, the Topmatic Labeller was still used for some products and therefore required an improvement team to help obtain the highest speed possible with least amount of stoppages from the machine.

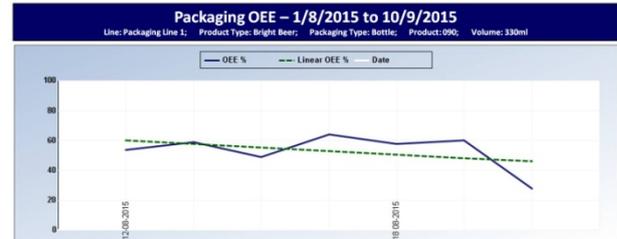
Figure 1: 6 Week % OEE Baseline (Topmatic Only)

- Baseline Measures (see OEE Baseline established in Figure 1);
- Operator Survey;
- MES (Manufacturing Execution System) data;
- OEE Line Observations; and
- Pareto Analysis.

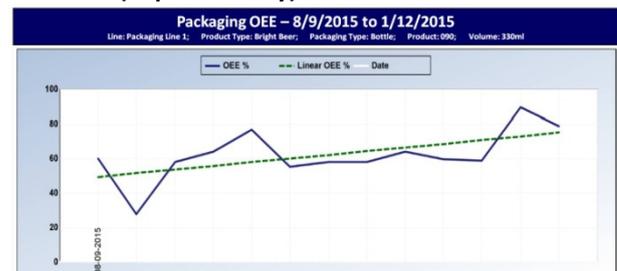
Figure 2: 53% to 75% OEE Improvement in 12 weeks (Topmatic Only)

The initial OEE Line Observation identified a number of improvements. From only *some minor changes that could be implemented immediately, the speed of the machine increased from 880 bottles per minute (BPM) to 980 BPM* (just below the maximum speed of 1000 BPM).

Throughout the cycle some further adjustments to the machine were made, which allowed the *team to achieve the maximum speed of 1000 BPM with no increase in stoppages, hence improving OEE to an average of 75%* as shown in Figure 2 below.

Improving the % OEE by reducing stoppages and waste on the Line, was contributed to by the following 12 improvements:

1. Reposition of Date Coder on out-feed of machine;
2. Replace In-feed Conveyor Guide Rail on Singuliser (Refer to Figure 3);
3. Overhaul of In-feed Worm Gearbox;
4. Program Singuliser for better bottle handling;
5. Rectify timing between magazine and last bottle;

6. Investigate work required to install new worm design;
7. Pre start-up Glue mechanism needs to be re-instated and Operators trained;
8. Review line control on out-feed into BW250;
9. Improve guard on out-feed conveyor rejecter;
10. Implement a new Operator Start / Stop panel;
11. Conduct FMEA on Topmatic Labeller; and
12. Install an indicator light on Date coder, so that Operators know when it goes out.
